analyst view

Perceptions of Hydrogen Fuelling Safety

18 JULY 2012

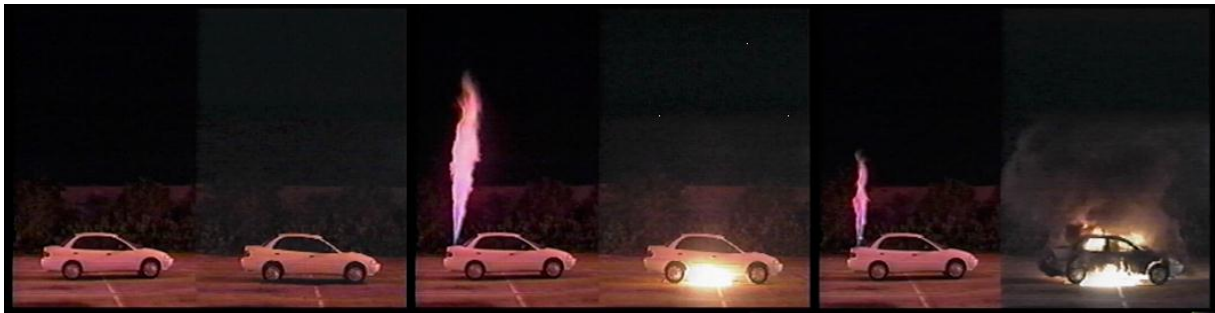
Across 80 stations only one ignition was recorded. Although this assessment cannot be fully comprehensive, to put it into some context the US NFPA (National Fire Protection Association) [reports](#) that between 2004 and 2008, on average, one in every thirteen conventional service stations experienced a fire. These fires caused an annual average of two civilian deaths, 48 civilian injuries and \$20 million in property damage. [61% of these fires](#) were vehicle fires, most commonly started by gasoline ignition. [A 2001 study](#) undertaken by Dr Michael Swain of the University of Miami used two test vehicles to simulate two car fires, one created by a 1/16th inch puncture in a gasoline fuel line, the other by a leaking hydrogen connector. Images taken from his video recording of the experiment at 0 seconds, 3 seconds and 1 minute demonstrate the quick and contained upwards ignition release of hydrogen and the ignition of the gasoline tank engulfing the entire vehicle in flames.

Hydrogen is lighter than air and although explosive, quickly escapes upwards when released, meaning that fires typically begin with an explosion but quickly run out of fuel. This is unlike petrol or diesel, which are flammable liquids that result in longer-lasting and typically more dangerous fires when leaked. The US Department of Energy (DoE), via the Pacific Northwest National Laboratory, has long maintained a user-populated database of hydrogen incidents, [H2Incidents.org](#). The database contains a total of twenty fuelling station problems recorded between 2007 and 2010, of which only eight are classified as incidents; of these eight incidents, three were the result of human errors, two involved no hydrogen release, only one resulted in ignition, and none resulted in major injuries or fatalities. By the end of 2010 there were 212 hydrogen refuelling stations in the world, according to the TÜV SÜD-operated database [H2Stations.org](#), approximately 80 of which were in the USA, including a station at Los Angeles LAX International Airport that has been safely operating since 2004.
